Manhole Inspection Summary

Manhole # S21G__010MH

Insp Date: **8/27/07 9:40 AM**

Location Address: **1900 FAIRMOUNT AVE**

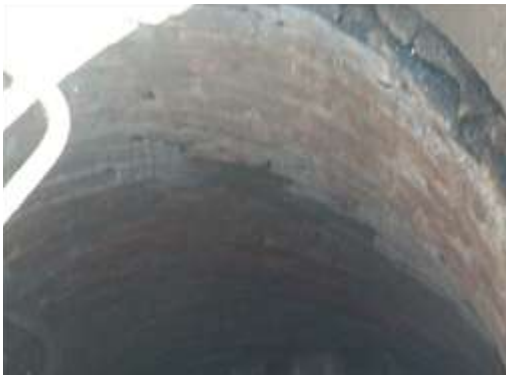
Defect 4

Infiltration: ☐ None ☐ Joint ☐ Cracks ☐ Mortar ☐ Roots ☒ **Wall**

CORBEL INFILTRATION

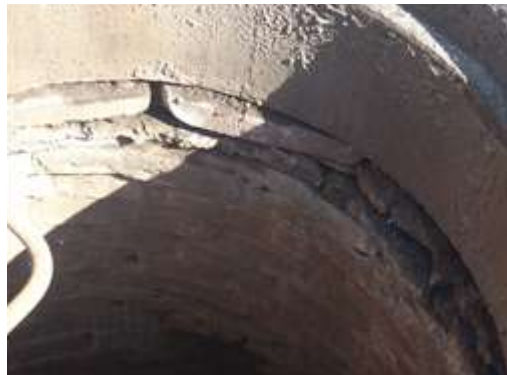
Defect 3

Condition: ☐ Sound ☐ Cracked ☐ Root Intrusion ☐ Loose Brick ☒ **Deteriorated**

DETERIORATION OF CHIMNEY

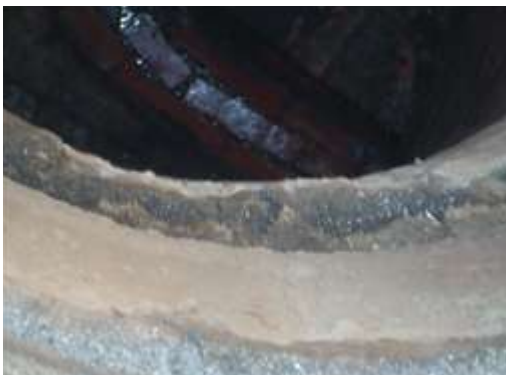
Defect 2

Offset: **1** (in.)

FRAME OFFSET

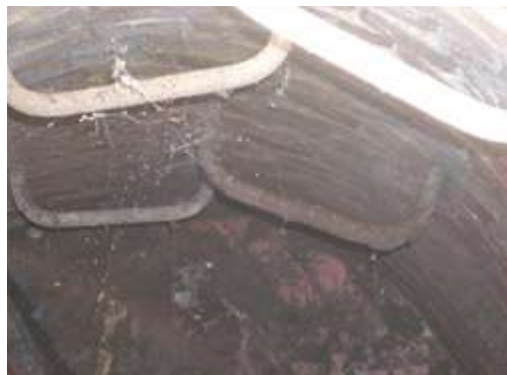
Defect 1

Count: **4** Missing: **0** ☒ **Corroded**

CORRODED STEPS

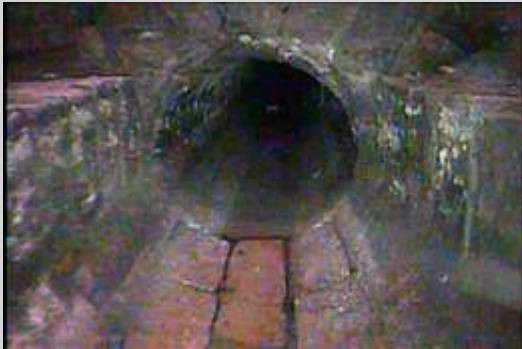
12 O'Clock Outflow

8 in. Circular Gravity Sewer
Pipe Out @ 12 O'Clock

Pipe Height: **8.4** (in.) Rod and Bar (Angled)
Pipe Material: **Clay** ☐ Pipe Lined
Invert Depth: **7.39** (ft.) Flow Characteristics: **Slow**
Deposits: ☒ None ☐ Mud ☐ Sludge ☐ Debris ☐ Grease
Silt Depth: (in.) Deposits Extent:
Infiltration: **None** Pipe Seal Cond: **Sound**

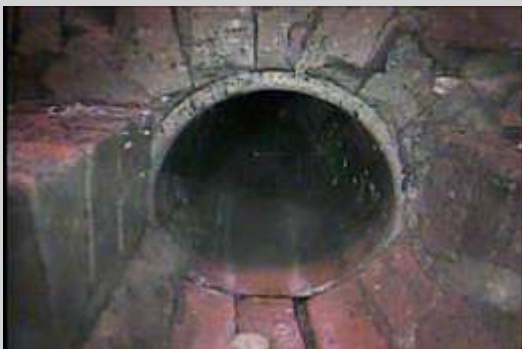
4 O'Clock Inflow

8 in. Circular Gravity Sewer
Pipe In @ 4 O'Clock

Pipe Height: **8.4** (in.) Rod and Bar (Angled)
Pipe Material: **Clay** ☐ Pipe Lined
Invert Depth: **7.19** (ft.) Flow Characteristics: **Slow**
Deposits: ☒ None ☐ Mud ☐ Sludge ☐ Debris ☐ Grease
Silt Depth: (in.) Deposits Extent:
Infiltration: **None** Pipe Seal Cond: **Sound**
